Updating the Firmware in the BAM-1020 Particulate Monitor

The firmware is the operating system program which controls all of the functions of the BAM-1020. This program is located in the EEPROM chip on the CPU circuit board, and the revision number of the firmware can be seen on the main screen of the BAM-1020 display. The firmware is occasionally revised by Met One to fix minor bugs or to add features. The firmware file can be updated by physically replacing the EEPROM chip with a new one supplied by Met One, or it can be flash updated through the BAM-1020 serial port using a computer and a small update utility program supplied by Met One. Contact the Service Department at (541) 471-7111 if difficulty is encountered.

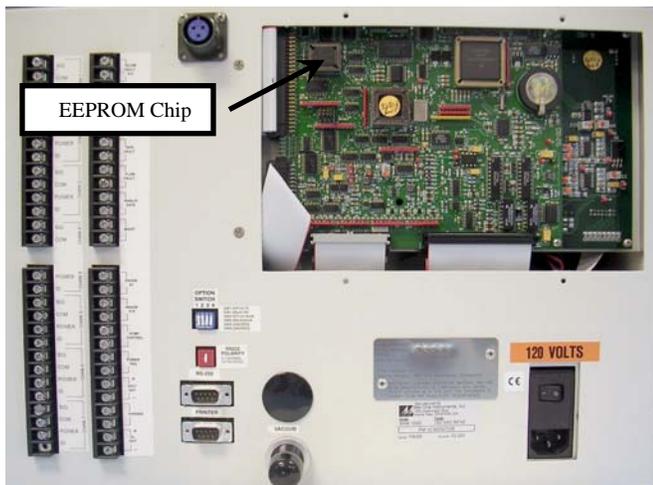
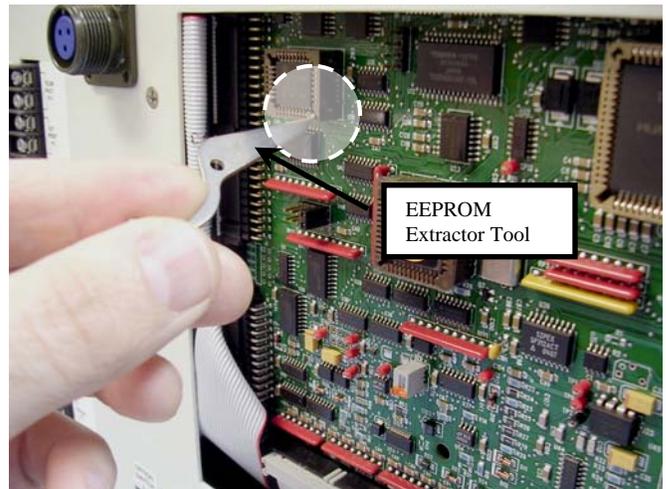
Replacing the EEPROM on a BAM-1020

4. Remove the old EEPROM with the supplied metal extractor tool. The tool inserts into the slots in the corner of the chip socket as shown below. Carefully pry the old chip loose.

5. Carefully snap the new EEPROM into the socket. Turn the BAM on and verify that the display is functional before replacing the cover plate. The new firmware revision will show on the display.

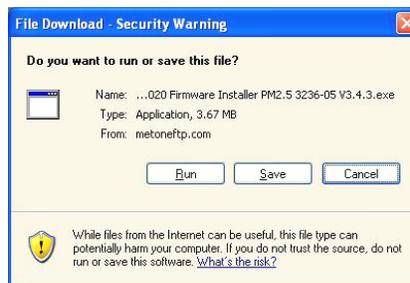
3. Click on the link or paste it into your internet browser address bar. After a moment the following window should appear:

You can run the executable installer program if this is the same computer you plan to use to update the BAM unit, otherwise click “Save” and save the installer to the hard drive or to a removable drive that you can use to transfer the file to the computer you plan to use for the update.

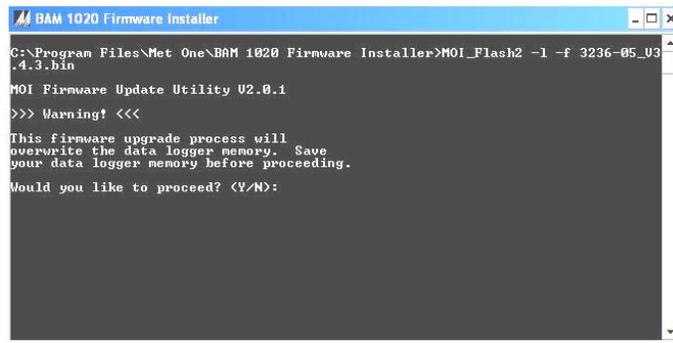
4. Transfer the executable installer file to the appropriate computer if needed, then run the program to install the Firmware Update Utility. The installer will guide you through the installation steps.
5. Connect the COM port of the computer (usually COM 1) to the RS-232 port on the BAM-1020 with the standard BAM serial cable. The BAM-1020 should be set to 9600 baud in the SETUP menu, if not already. The BAM must be powered on and displaying the main screen.
6. From the Windows **Start** menu, go to Programs/Met One/BAM 1020/BAM 1020 Firmware Installer to run the Firmware Update Utility program as shown below. The program will prompt you to save the BAM data. Hit **Y** and the **Enter** key to proceed. The program will then prompt you for the COM port number. Enter the number (usually **1**) and press the **Enter** key to begin the update process.

```
C:\Program Files\Met One\BAM 1020 Firmware Installer>MOI_Flash2 -l -f 3236-05_U3
.4.3.bin
MOI Firmware Update Utility U2.0.1
>>> Warning! <<<
This firmware upgrade process will
overwrite the data logger memory. Save
your data logger memory before proceeding.
Would you like to proceed? <Y/N>:
```
